Manhole Inspection Summary

Manhole # S41Y1_015MH

Insp Date: **12/5/07 9:07 AM**

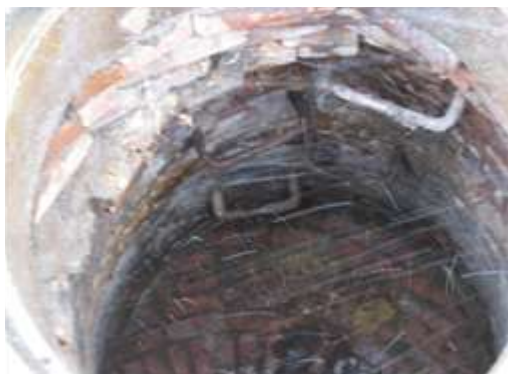
Steps Count: **3** Missing: **1** ☒ **Corroded**

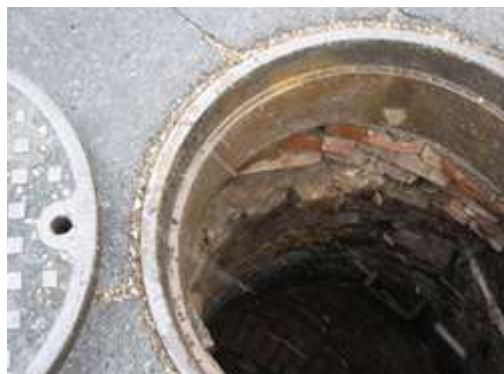
Defect 1

Condition: ☐ Sound ☒ **Cracked** ☐ Root Intrusion ☒ **Loose Brick** ☒ **Deteriorated**

Infiltration: ☐ None ☒ **Joint** ☒ **Cracks** ☒ **Mortar** ☐ Roots ☐ Wall

loose bricks & mortar

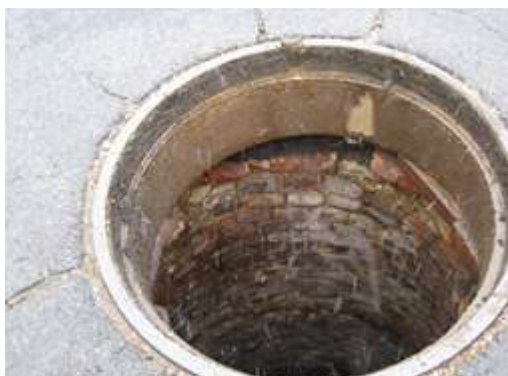
Defect 2

Missing bricks

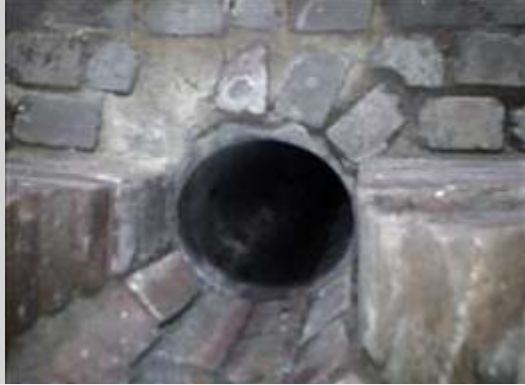
12 O'Clock Outflow

8 in. Circular Gravity Sewer
Pipe Out @ 12 O'Clock

Pipe Height: **10.8** (in.) Rod and Bar (Angled)
Pipe Material: **Clay** ☐ Pipe Lined
Invert Depth: **8.69** (ft.) Flow Characteristics: **Slow**
Deposits: ☒ None ☐ Mud ☐ Sludge ☐ Debris ☐ Grease
Silt Depth: (in.) Deposits Extent:
Infiltration: **None** Pipe Seal Cond: **Sound**

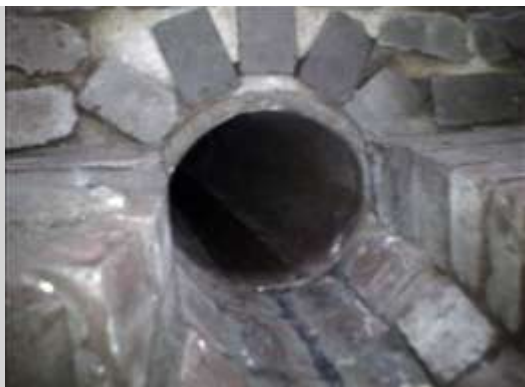
3 O'Clock Inflow

8 in. Circular Gravity Sewer
Pipe In @ 3 O'Clock

Pipe Height: **10.8** (in.) Rod and Bar (Angled)
Pipe Material: **Clay** ☐ Pipe Lined
Invert Depth: **8.43** (ft.) Flow Characteristics: **Slow**
Deposits: ☒ None ☐ Mud ☐ Sludge ☐ Debris ☐ Grease
Silt Depth: (in.) Deposits Extent:
Infiltration: **None** Pipe Seal Cond: **Sound**
